# Riparian Vegetation Management: Reconciling Environmental and Anthropogenic Issues

Caroline Zanetti\*, Nelly Liency

ARBEAUSOLutions, Belcodène, France

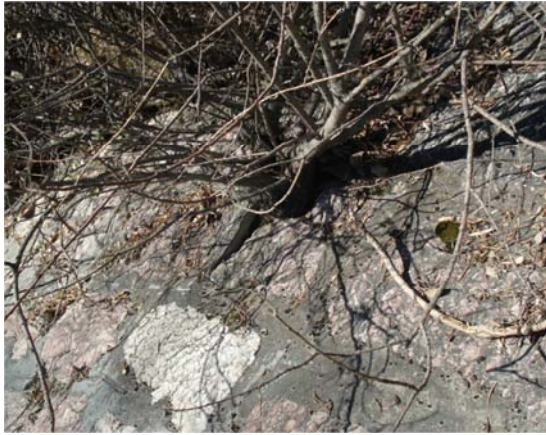
**Figure 1.** On going destruction of a retaining stone and masonry rip rap by a poplar cut several times. When trees are cut many times, their root system in growing faster and stronger, resulting on heavy degradations, like here with uprising of concrete joint.

When root systems develop in the structure's surface where the upstream faces consist of asphalt, concrete slabs, jointed stone or riprap, materials can lift, crack, and lose their protective function and especially sealing functions (Figure 1). The roots easily colonize the joints and degrade them; they can be the cause of cracks widening, invasion and the clogging of drains.

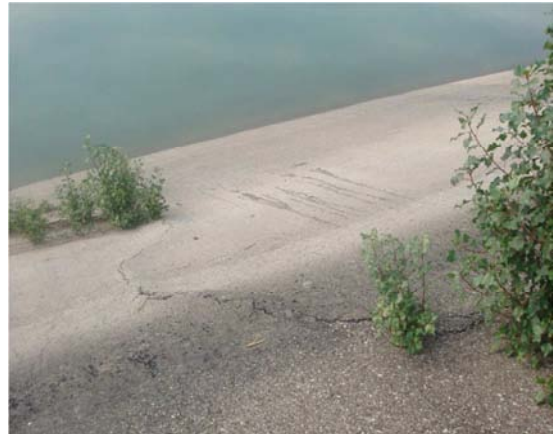
**Figure 2.** Apparition of numerous root suckers along a fissure on protective tar coating, generated by a shallow root resulting from the slaughtering of the main tree.

In the case of trees growing in protective coatings, the cutting of these subjects is usually carried out as a first-effort. The result is, at this time only, visual (apart from allowing to regain hydraulic capacity) and short-term. Indeed, this cut aggravates the problem with the appearance of rejects and suckers which increases the colonized surfaces and the degradations (Figure 2).

Cutting young trees reinforces their root system and induces new shoots development which bring reserves to the stump which thus continues its growth.

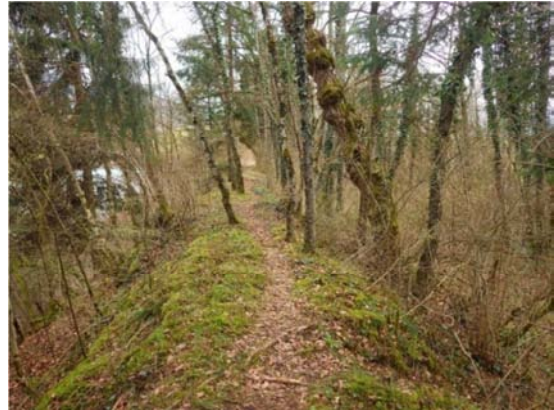
**Figure 3.** Entirely wooded dam presenting a critical condition in respect of the safety of the work. Trees are implanted on the both sides of the dike; most of them are dangerous in case of uprooting.

several decades. They constitute preserved zones but are not functional anymore and present a probability of very important failure (Figure 3).

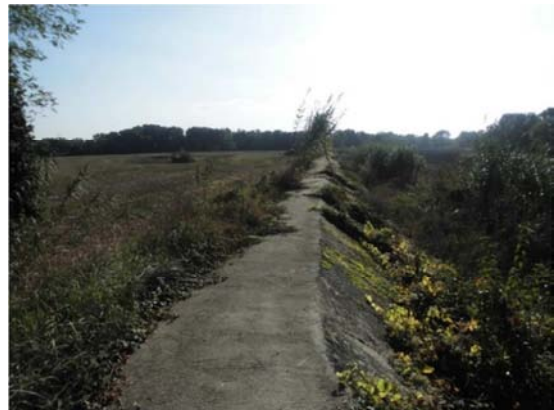
**Figure 4.** Entirely concreted dike where the invading species still manage to grow and deteriorate the concrete.

Conversely, many works of protection against floods were conceived or are managed in a very drastic way, whether entirely "concreted" or "tarred" (Figure 4), and where the chemical means were before largely used for the eradication of the woody plants.

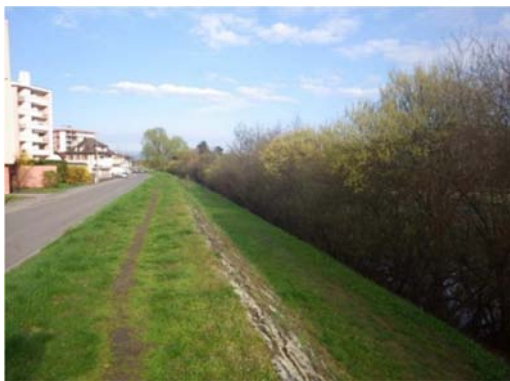
**Figure 5.** Illustration of the good reconciliation of the GEMA and PI issues. a bank protected by plant techniques and a dike kept in grass favoring the diversity of environments.

When plant techniques alone are not enough to protect the banks (though they may be preferable), vegetated rip raps offer a very interesting alternative (Figure 5).

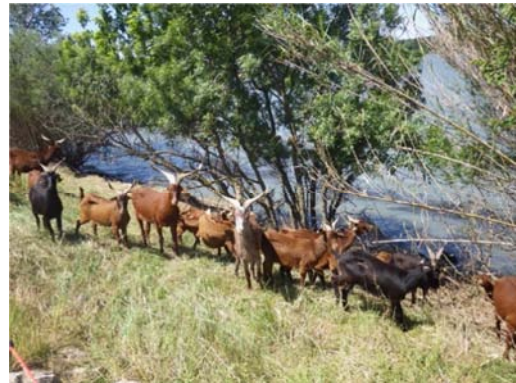
**Figure 6.** Return to ancestral methods in order to avoid the use of chemicals products.

In order to provide an economic and ecological solution, eco-grazing, which involves grazing animals (sheep, goats or cattle), conserves natural areas and helps to preserve biodiversity (Figure 6). This ancestral method aims to keep environments open by preventing brush and shrubs from colonizing the space. Eco-grazing limits the use of mechanical devices and avoids the use of chemicals.

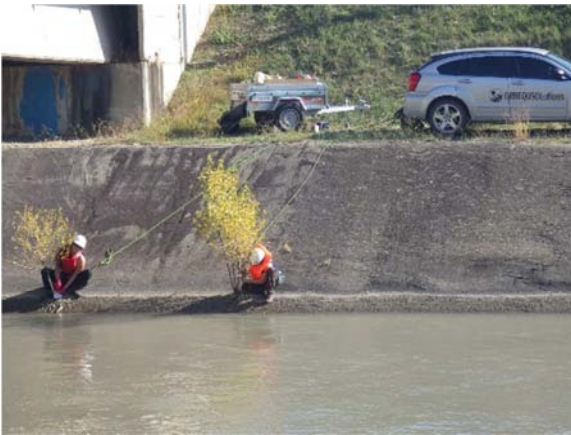
Figure 7. Innovative solutions for vegetation control are implemented by ARBEAUSOLutions on canal dikes.

New solutions based on the physiology of trees are in research and development with some new solutions for which a patent is pending (Figure 7). These new methods allow young tree devitalization that respect the environment and does not damage hydraulic structures. Reparations are thus largely minimized.

These new solutions for the control of young woody species growing on structures are based on the disruption of the good metabolic functioning of the tree, notably by disturbing the flow of sap from the roots, essential for the aerial part development and for the constitution of reserves and ensuring the durability of the tree (Figure 7).

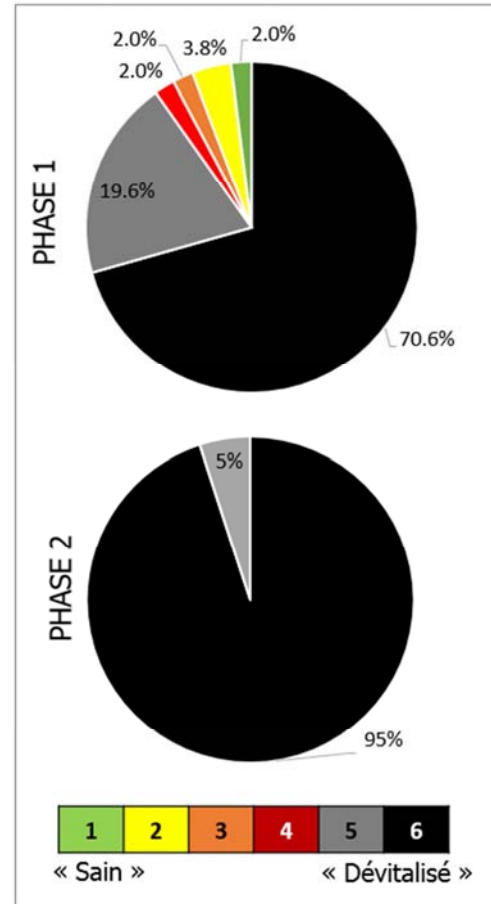
Figure 8. Results of devitalization of poplars by innovative processes in 2 phases developed by ARBEAUSOLutions. the second phase results are observed at the next spring, one year after the first experimentation.

Part of these methods are based on the optimization of existing techniques used in forestry management. Debarking wood is a method used in the forestry environment to thin afforestation and promote the development of certain target trees by causing decay of the one economically less profitable for afforestation. Debarking is also a recognized method in the field of management of invasive woody species and gives interesting results. Applied alone, the negundo maple girdling has a success rate of 65%, which is still low compared to chemical devitalization techniques using phytocides that devitalize the standing tree. This success rate also depends on the type of woody species. It is less than 60% on poplars. One of the solutions patented by ARBEAUSOLutions achieves a 90% success rate by combining girdling with other biochemical and/or thermal techniques (70% devitalized subjects in Phase 1 and 95% after Phase 2 on a total of 80 subjects treated (Figure 8).

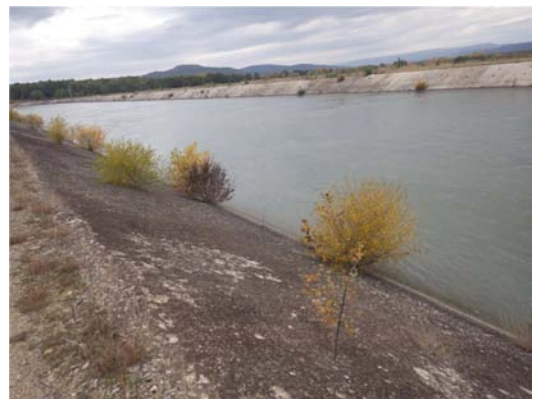
Figure 9. Colonization of concrete lock walls by young poplars which are present in drainage system breaks.

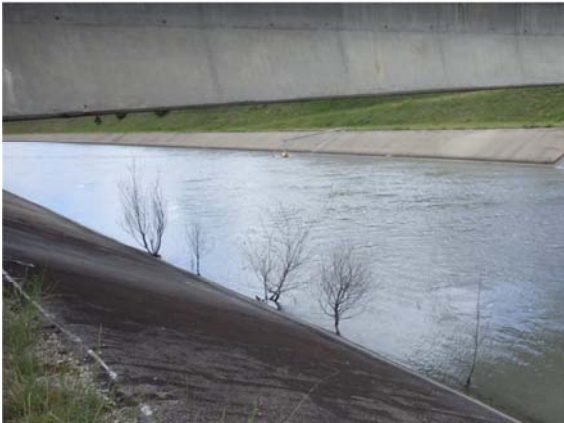
**Figure 10.** Devitalized poplars through innovative ARBEAUSOLutions processes; research conducted for 5 years in INRA lab, green houses and on work sites.
